# Analysis and Simulation of Two Severe Wind and Ice Storms in the Highest Regions of Central Balkan

**Abstract.** Two severe wind storms happened in November 1964 and December 2012 in the highest regions of the central part of the mountain Stara planina – the Central Balkan. They caused heavy damages to the technical equipment and the buildings along the ridge of the mountain – in 1964 the roof of the main TV building was blown away by strong north winds and the TV tower itself was broken. The whole area of the damages spreads over 30 km. In 2012 a Mediterranean cyclon hit the same regions with powerful south winds and a smaller radio tower collapsed due to the heavy wind and ice load. The purpose of this study was to evaluate the meteorological conditions during these events with focus on the wind and ice severity. We have analyzed the synoptic condition at different pressure levels in order to estimate the main dynamic of the atmosphere over the Balkan Peninsula and we have used WindNinja version 3.8.1 for simulation of the surface wind field in a smaller region. Finally, using simple icing model we have estimated also the possible ice load. WindNinja is a numeric aerodinamical

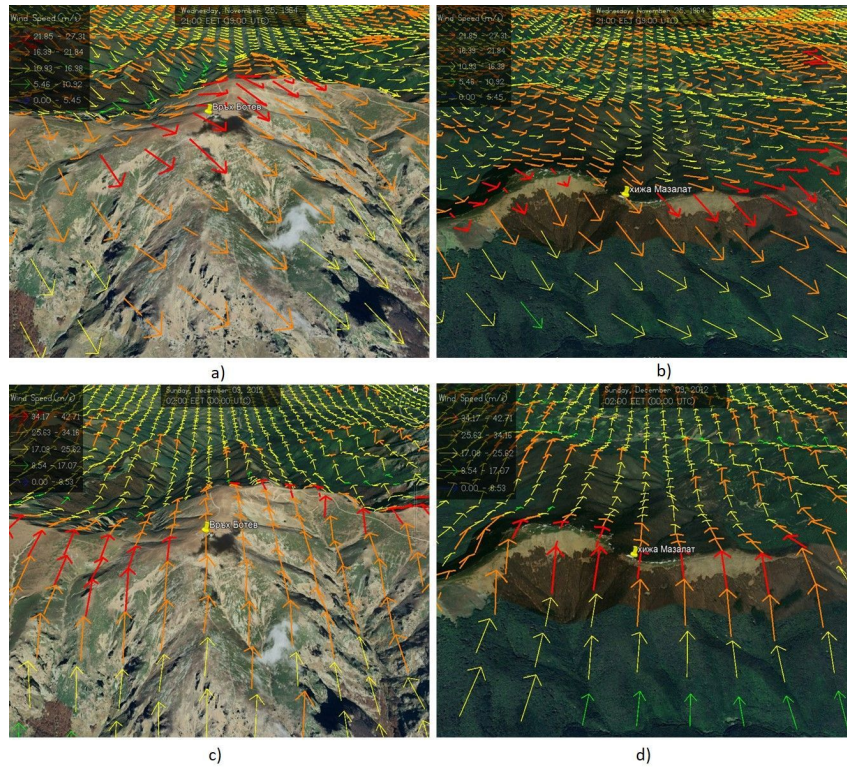
In Figure 5 it is shown simulated by numerical model surface wind field at the peak of the storms – (a) for Botev peak and (b) and for the cabin Mazalat in 1964 and on (c) and (d) for that storm in 2012 respectively. The comparison of measured and calculated wind characteristics for both storms is represented in Table 1. A good coincidence between the calculated and measured values of surface wind parameters is observed. Relatively larger differences between the calculated and measured wind values are observed for the Mazalat hut, which is due to the distance of the station from peak Botev (about 16 km in the Eastern direction). In Figure 5a it is shown the surface wind field in the peak region at 9 pm (EET) on 25 November. Measurements for Botev peak in this period show a wind speed of 24 m/s from the NW and they coincide very well with the calculations from the numerical model – 23.9 m/s with a NW direction (Table 1). At the same time, in the Mazalat Hut area, the model calculates 20.8 m/s with

Figure 5. Surface wind field in the area of: (a) Peak Botev at 21 (EET) on November 25, 1964; (b) at the Mazalat hut at 21 (EET) on November 25, 1964; (c) on Peak Botev at 2 (EET) on December 9, 2012; (d) Mazalat Hut area at 2 (EET) on 9 December 2012.

a NNW direction (Figure 5b), while measurements show wind 20 m/s from the N. During the 2012 storm at 2:00 (EET) on December 9, a speed of 34 m/s and direction S was measured for peak Botev (Table 1), and the numerical model

calculated speed of 33.5 m/s and also direction S (Figure 5c). For Mazalat Hut, we have no measurements for this period because the station was closed in the 1990s, but the model shows a wind speed of 36.3 m/s from the S (Figure 5d).

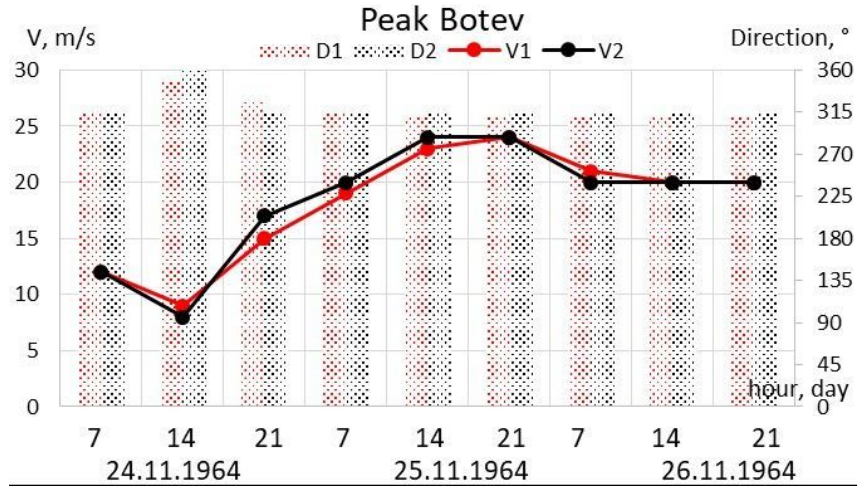
Figure 6. Variation in wind speed and direction during the 1964 storm.

From Figure 6, it can be seen that calculated by the numerical model wind speed and direction are fitted very well within the measured wind speed and observed wind direction in the station on the Botev peak. In the same way from Figure 7,

In both Figures 6 and Figure 7 with  $V$  (m/s) are represents wind speed values:  $V_1$  calculated by numerical model;  $V_2$  – measured wind speed and with  $D$  (°) – wind direction;  $D_1$  (evaluated by the model) and  $D_2$  – observed in station wind direction.

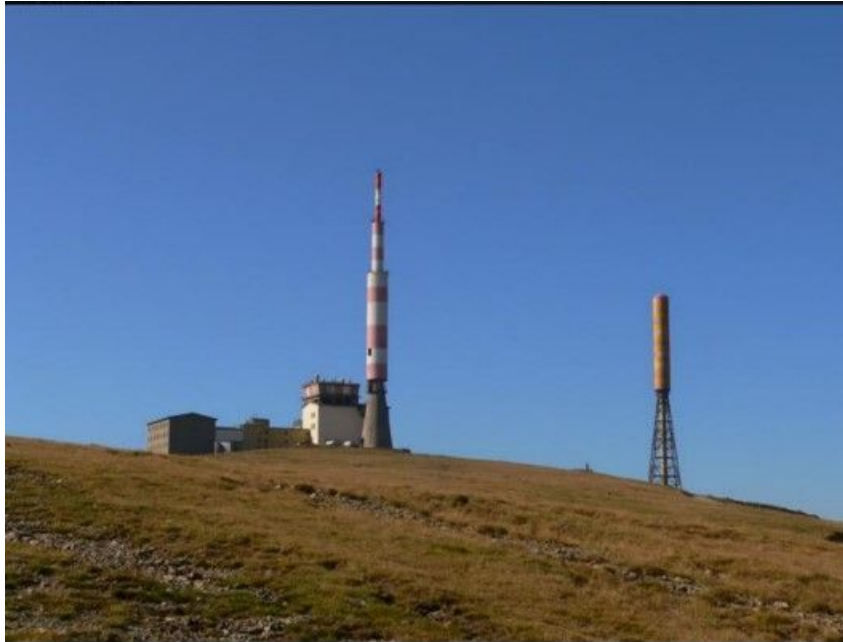
According to archival information in 1964 the roof of the TV station building on Botev peak was blown away. The measured wind gusts speed in this storm was 40 m/s from the NW at 10 m above the ground surface resulting in a static wind load of 0.85 kN/m<sup>2</sup>. Another incident occurred during the storm in 2012, when a tower with an antenna installed on it with a total height of 77 m, located in the area of the peak Botev station, was knocked down (Figure 9).

The right tower (Figure 9) has fallen, but the left tower with high of 100 m, still is in good condition and working well, as it was designed. The recorded speed of wind gusts was then 34 m/s from S at 10 m above the ground, which caused wind load of 0.61 kN/m<sup>2</sup> at this level. The normative value of wind speed for peak Botev is 45.8 m/s with static wind load of 1.31 kN/m<sup>2</sup> at 10 m above the

Figure 9. The towers of Botev peak before the 2012 accident.

surface. Estimated wind speed at high of 77 m is 43.4 m/s during the storm and the evaluations carried out according to the methodology and requirements of Eurocode 1 [5] show that a wind with such a speed generates a static load of  $1.18 \text{ kN/m}^2$  on the top of this tower. As the same time normative values for 77 m high are 63.4 m/s and static wind load of  $2.52 \text{ kN/m}^2$ .

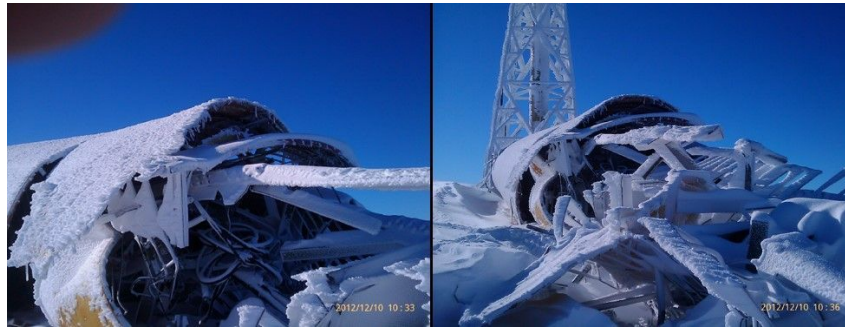
Rime icing was reported from constantly with interruption only on the 10-th December. On the next day, the process started again but the tower had collapsed already at the end of the first day (Figure 12). The duration of this first riming phase of the second event was 47 hours – just 10 hours more than the averaged. The icing intensity was evaluated visually as light to moderate. Icing of such large objects lies beyond the theoretical limits so far and that is way the riming of the tower was estimated using the recommendation of the international ISO 12494 “Atmospheric icing on structures” [6] and the photos of the collapsed tower. Based on all this can be concluded that the icing event on 08-09.12.2012 was moderate as severity and caused ice load of a magnitude between 11 and 20 kg/m.

Unfortunately we do not know if this estimation is crucial, because its design characteristics are unknown. However, most probably, the collapse was due to the general aging of the construction and the harsh meteorological conditions

Figure 12. Remains of the collapsed tower.

Most likely, the reason for the fall of the tower is the aging of the construction materials and insufficient maintenance of this equipment over the years. This fact shows how important is the maintenance of technical equipment in mountainous conditions to do regularly.
